**State of Louisiana  
Department of Natural Resources  
Coastal Engineering Division**

## **2005/2006 Annual Inspection Report**

### **GRAND-WHITE LAKES LANDBRIDGE PROTECTION PROJECT (ME-19)**

October 12, 2005  
Cameron Parish

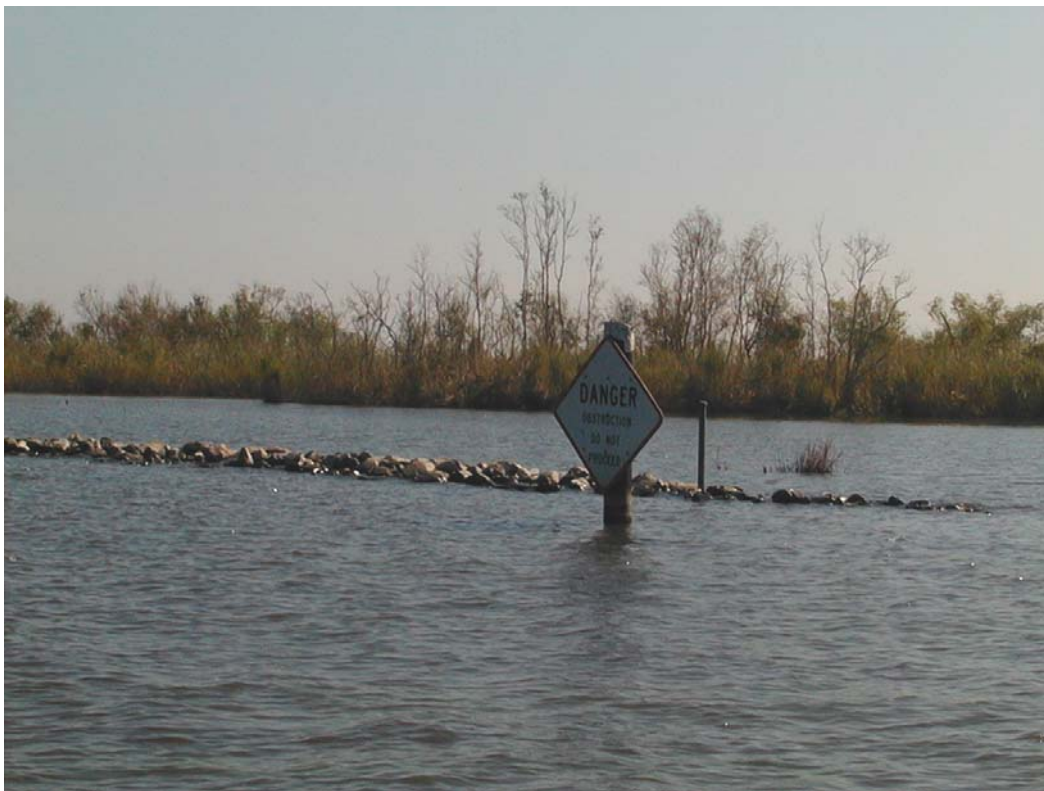
The foreshore rock dike feature is in excellent condition and appears to be in same condition as to what existed prior to Hurricane RITA. No maintenance is required at this time. (Photos: Appendix B, Photos 1 & 2)

Photo 1, Typical rock dike, note high water from Hurricane RITA storm surge.

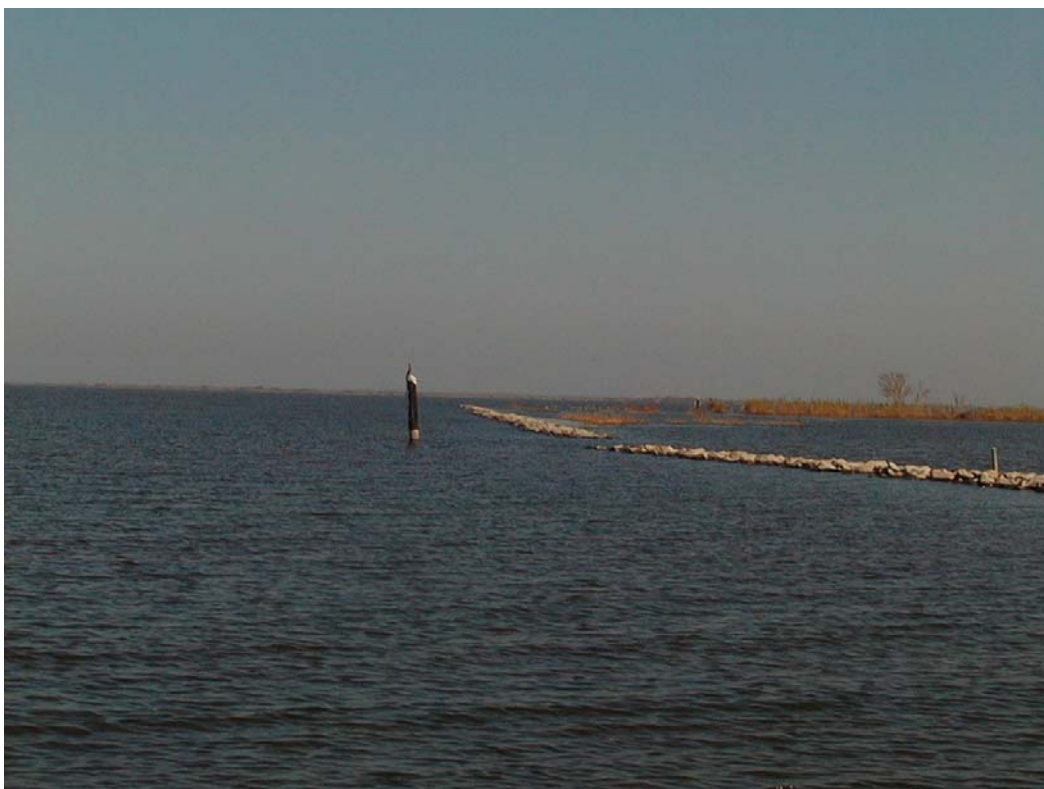
Photo 2, Rock foreshore dike.

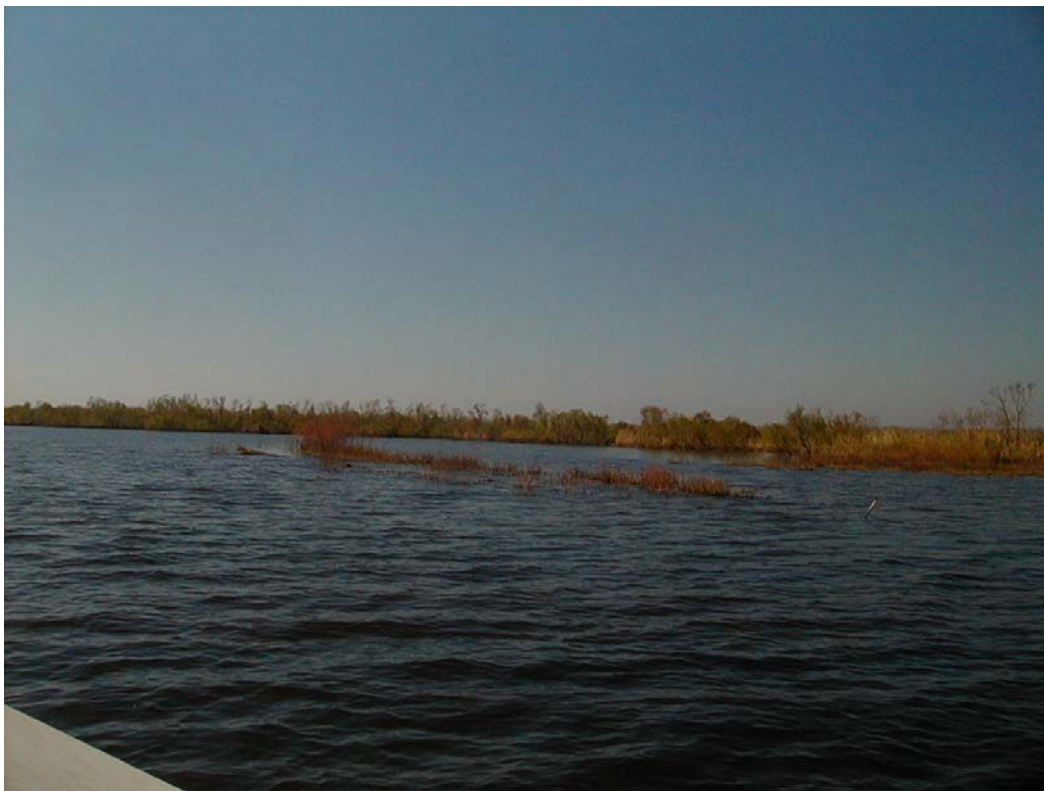
The condition of the shallow water earthen terraces feature of the project was unable to be determined due to the high water conditions. Previous O & M Annual Inspections did

note marsh side and lake side earthen terraces along Collicon Lake having experienced some erosion with the most extensive occurring on the East side of Collicon Lake. Original giant cutgrass plantings along the terraces were visible although appearing stressed. (Photos: Appendix B, Photos 3 & 4)

Photo 3, Earthen terraces submerged by high water.

Overall, the foreshore rock dike feature of the Grand-White Lake Landbridge Project is in excellent condition and is functioning as designed and did not sustain any discernable damage from Hurricane RITA. The earthen terrace feature along Collicon Lake has experienced some erosion and will be monitored in the future to determine if a maintenance or vegetative planting project is needed.

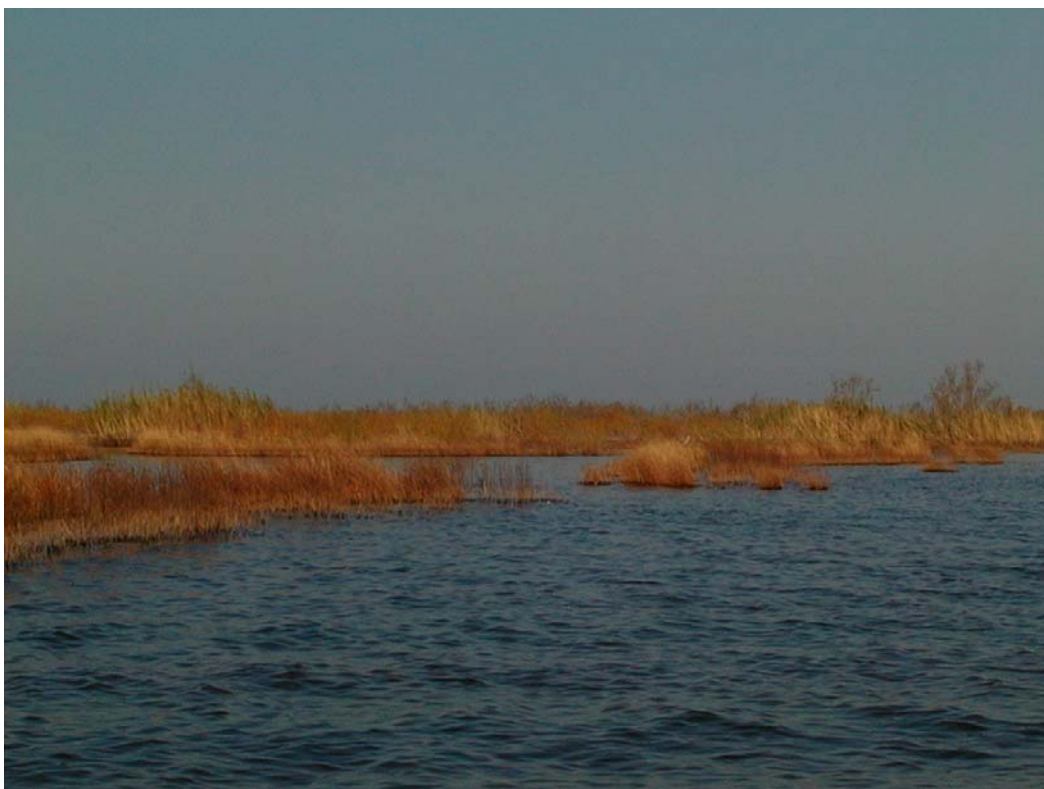
Photo 4, Earthen terraces
